Section 7	.....	
Inspection and Evaluation of Common Concrete Superstructures		
7.8	Prestressed Double Tees .....	7.8.1
7.8.1	Introduction .....	7.8.1
7.8.2	Design Characteristics .....	7.8.1
	General .....	7.8.1
	Primary Members and Secondary Members .....	7.8.3
	Steel Reinforcement .....	7.8.3
7.8.3	Overview of Common Defects .....	7.8.4
7.8.4	Inspection Procedures and Locations .....	7.8.4
	Procedures .....	7.8.4
	Visual .....	7.8.4
	Physical .....	7.8.4
	Advanced Inspection Techniques .....	7.8.5
	Locations .....	7.8.5
	Bearing Areas.....	7.8.5
	Shear Zones.....	7.8.6
	Tension Zones.....	7.8.6
	Secondary Members.....	7.8.6
	Areas Exposed to Drainage.....	7.8.6
	Areas Exposed to Traffic .....	7.8.7
	Areas Previously Repaired.....	7.8.7
	General.....	7.8.7
7.8.5	Evaluation.....	7.8.7
	NBI Rating Guidelines .....	7.8.7
	Element Level Condition State Assessment.....	7.8.7

# Topic 7.8 Prestressed Double Tees

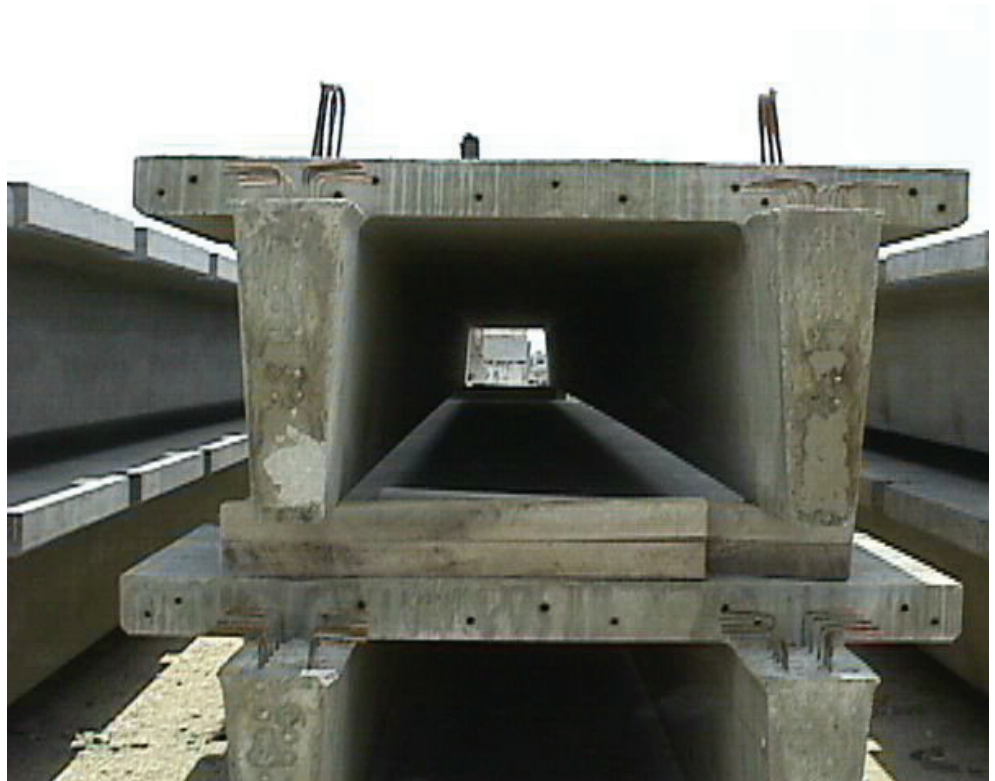
A prestressed double tee beam, like the name implies, resembles two capital letter T's that are side by side (see Figure 7.8.1). The horizontal section is called the deck or flange, and the two vertical leg sections are called the webs or stems. This type of bridge beam is mostly used in short spans or in situations where short, obsolete bridges are to be replaced.

**Figure 7.8.1** Typical Prestressed Double Tee Beam

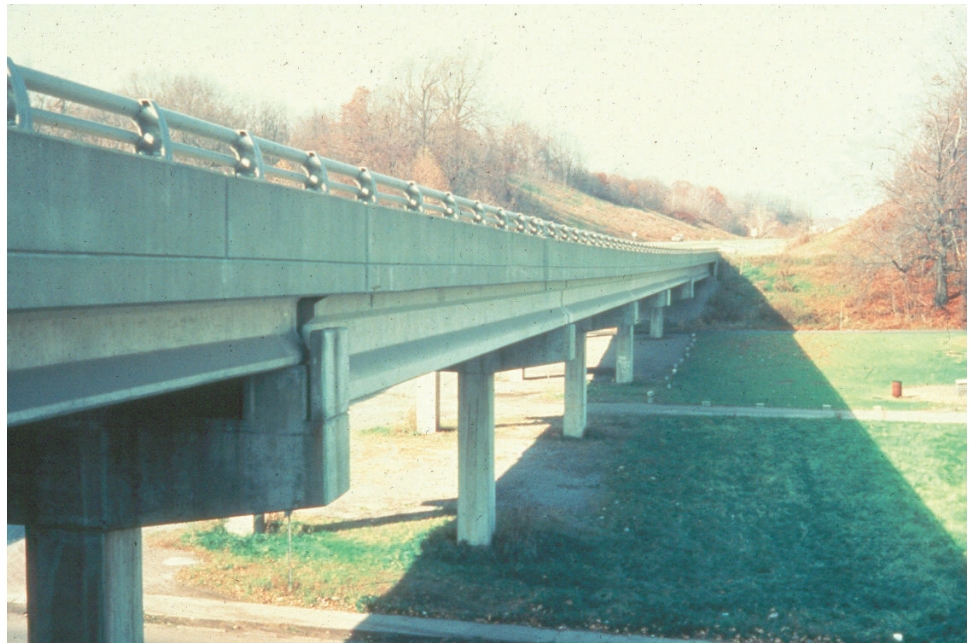
Prestressed I-beams and bulb-tees have been used since the 1950's. They have proven to be effective because of their material saving shapes. The I or T shape allows a designer to have enough space to place the proper amount of reinforcement while reducing the amount of concrete needed (see Figure 7.9.1).

**Figure 7.9.1** Prestressed I-beam Superstructure

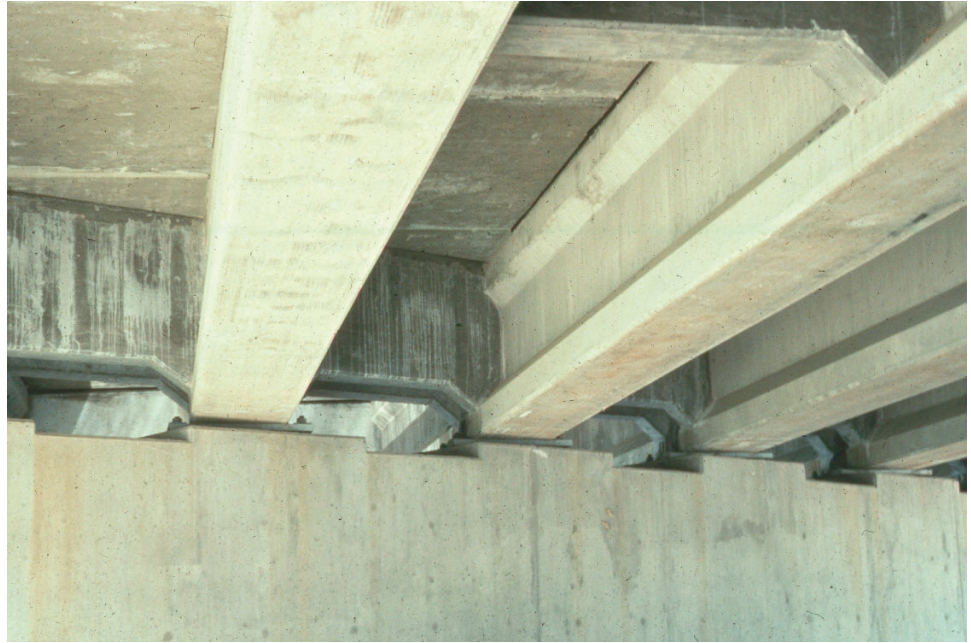
The primary members are the prestressed beams. The secondary members are the end diaphragms and the intermediate diaphragms. End diaphragms are usually full depth and located at the abutments or piers. Intermediate diaphragms are partial depth and are used within the span for longer spans (see Figure 7.9.7). Diaphragms are cast-in-place concrete or rolled steel sections and are placed at either the end points, mid points, or third points along the span.

**Figure 7.9.7** Concrete End Diaphragm

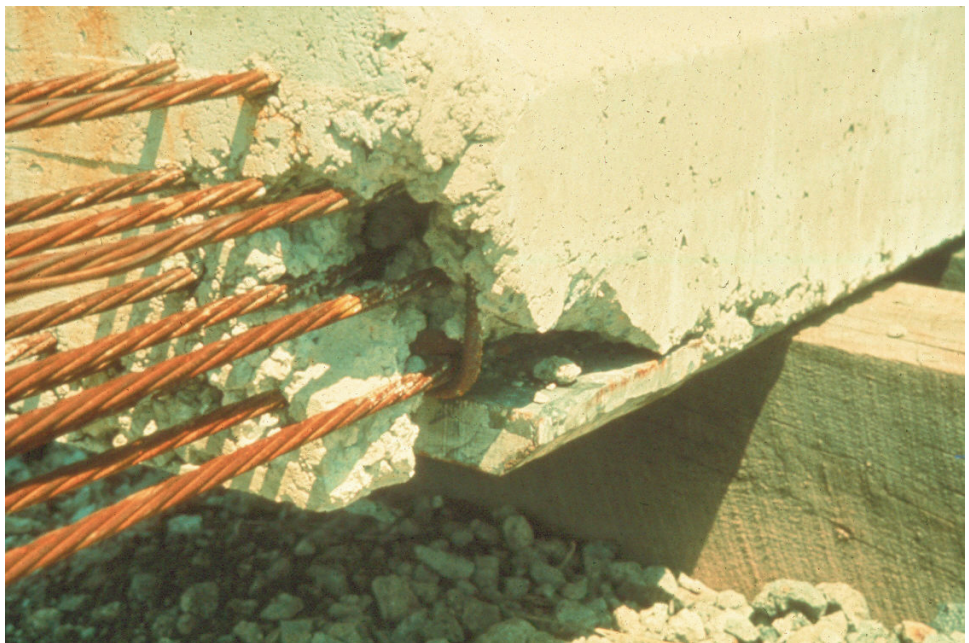
**Figure 7.9.10** Spalling Due to Poor Concrete

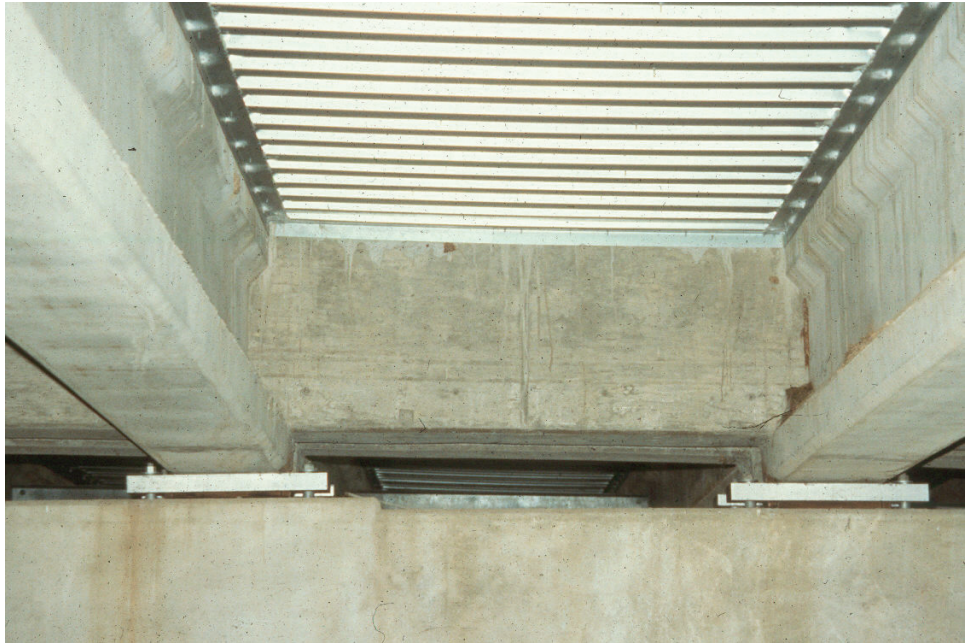
**Figure 7.9.12** Typical Concrete Diaphragm

Inspect the end diaphragms for spalling or diagonal cracking (see Figure 7.9.12). This is a possible sign of overstress caused by substructure movement.

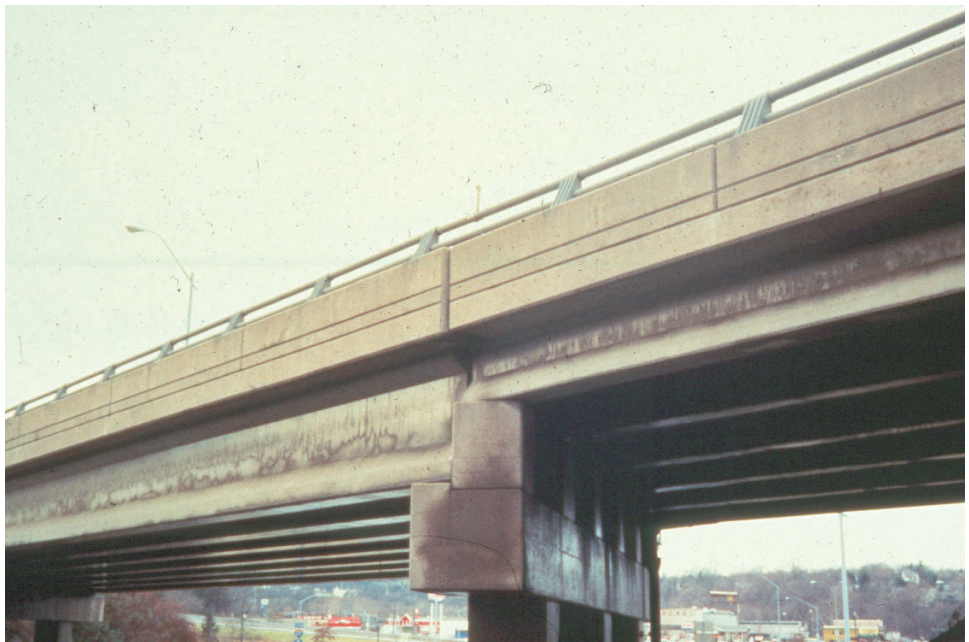
Check around joints, scuppers, inlets or drain holes for leaking water or deterioration of concrete (see Figure 7.9.13).

**Figure 7.9.13** Leakage of Water at Joint between Spans

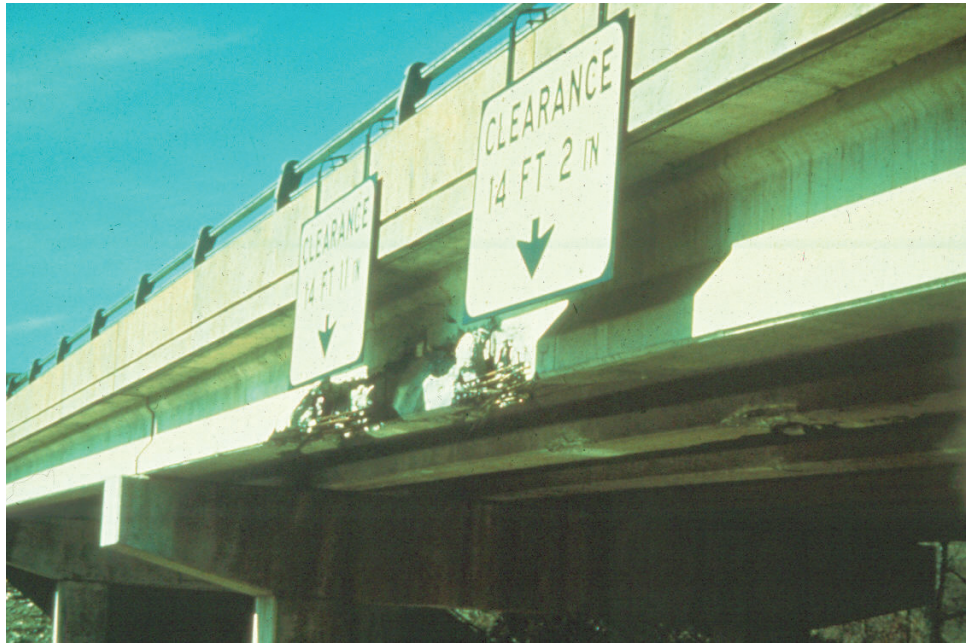
Check areas damaged by collision. A significant amount of prestressed concrete bridge deterioration and loss of section is caused by traffic damage. Document the number of exposed and severed strands as well as the loss of concrete section. The loss of concrete due to such an accident is not always serious, unless the bond between the concrete and steel reinforcement is affected (see Figure 7.9.14).

**Figure 7.9.14** Collision Damage on Prestressed Concrete I-beam

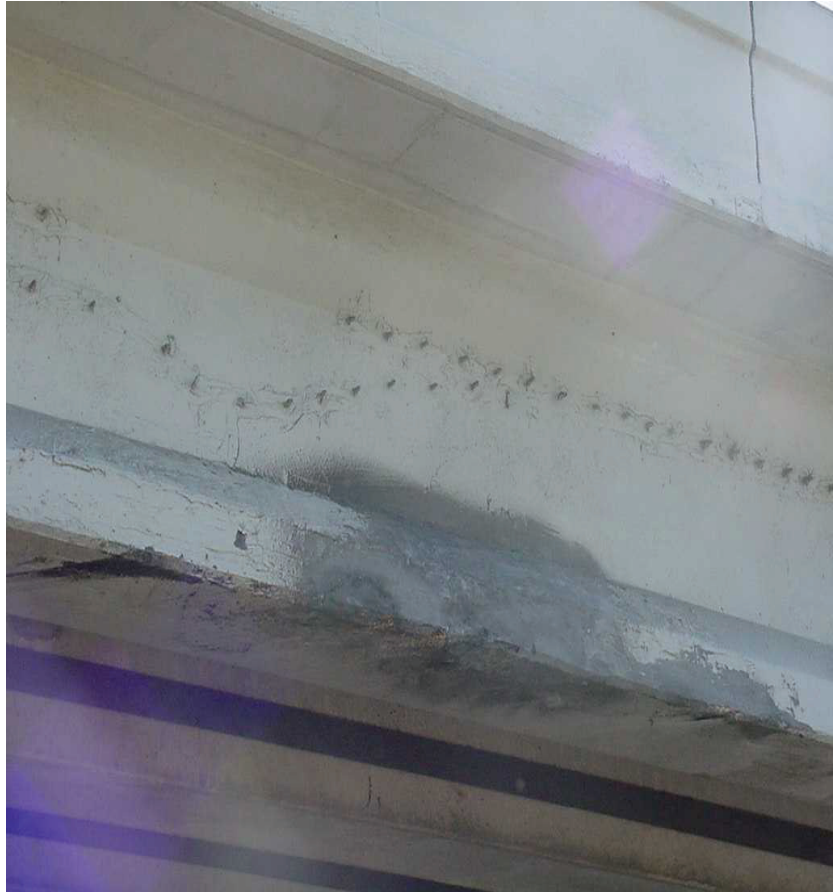
Examine thoroughly any repairs that have been previously made. Determine if repaired areas are sound and functioning properly. Effective repairs and patching are usually limited to protection of exposed tendons and reinforcement (see Figure 7.9.15).

**Figure 7.9.15** Collision Damage Repair on Prestressed Concrete I-bBeam. Note Epoxy Injection Ports

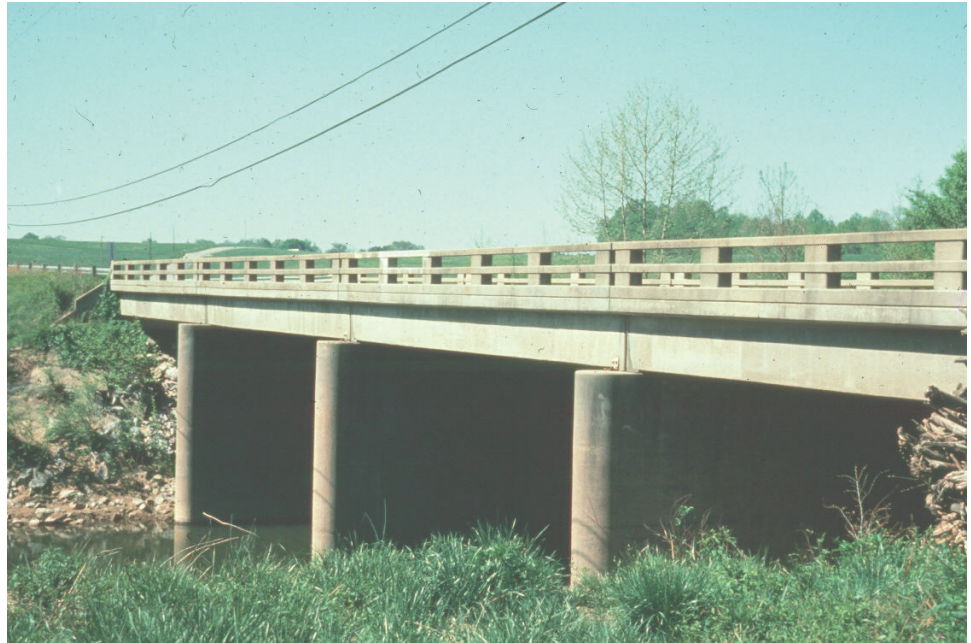
Prestressed box beams are quite popular and have been used since the early 1950's (see Figure 7.10.1). These precast prestressed members provide advantages from a construction and an economical standpoint by increasing strength while decreasing the dead load.

**Figure 7.10.1** Typical Box Beam Bridge

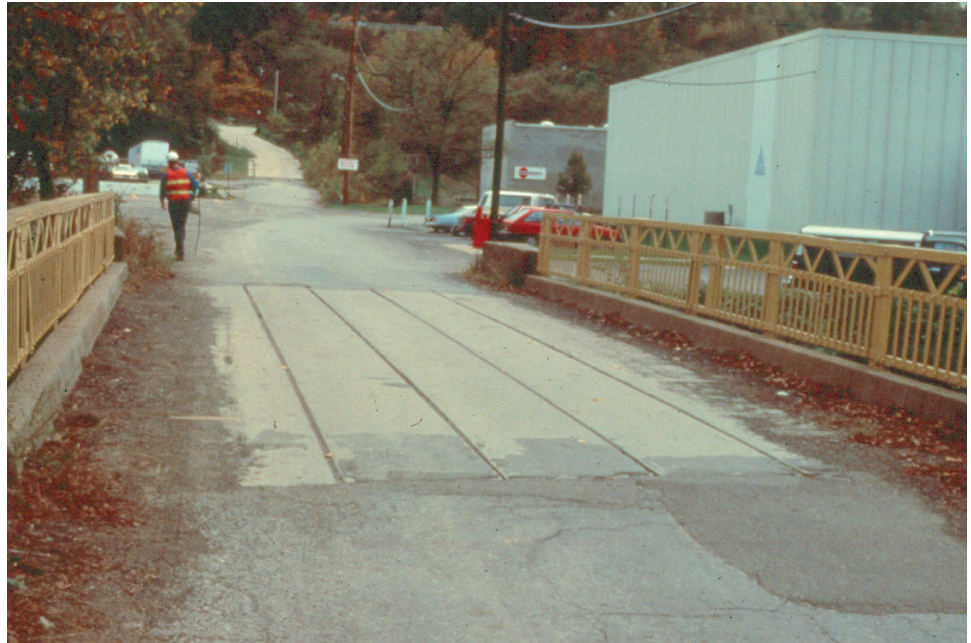
On an adjacent box beam bridge, the adjacent box beams are placed laterally side by side with no space between them. In some early applications, the top flange of each box is exposed and functions as the deck (see Figure 7.10.5). The practical span lengths range from 6 to 40 m (20 to 130 feet), with the most economical spans ranging from 12 to 27 m (40 to 90 feet).

**Figure 7.10.5** Adjacent Box Beams: Top Flanges Acting as the Deck

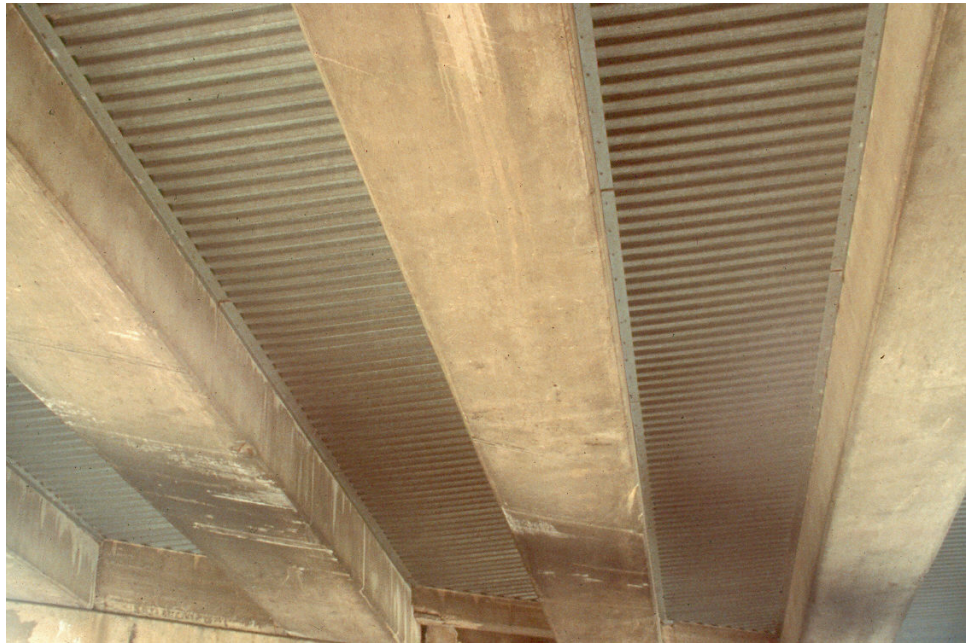
On a spread box beam bridge, the box beams are usually spaced from 610 to 1830 mm (2 to 6 feet) apart and typically use a composite cast-in-place concrete deck (see Figure 7.10.7). This application is practical for span lengths from 8 to 26 m (25 to 85 feet). Stay-in-place forms or removable formwork is used between the box beams to provide a support when the concrete deck is placed.

**Figure 7.10.7** Underside of a Typical Spread Box Beam

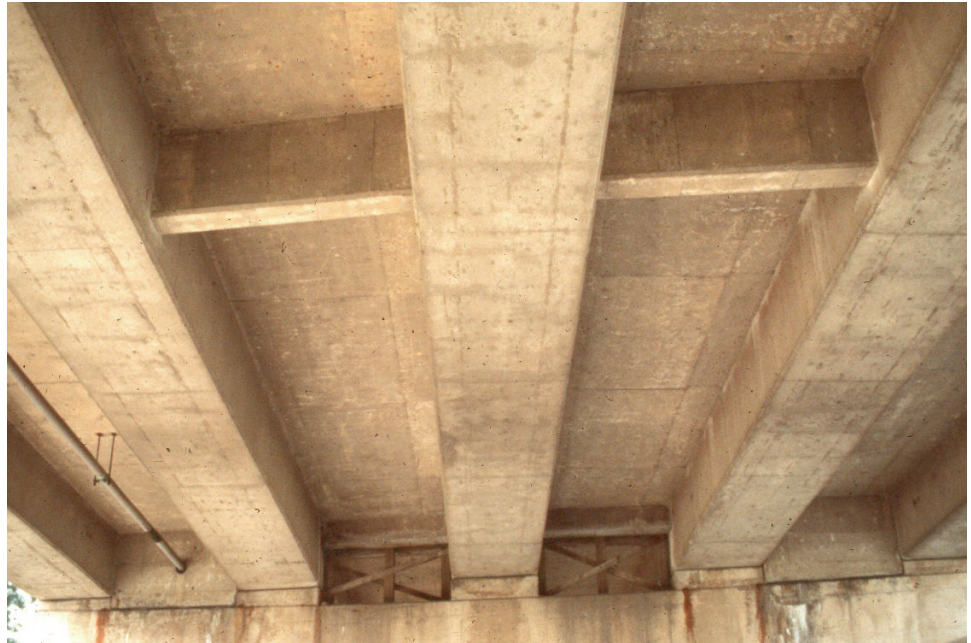
The primary members of box beam bridges are the concrete box beams. External diaphragms are the only secondary members on box beam bridges, and they are only found on spread box beam bridges (see Figure 7.10.8). The diaphragms may be cast-in-place, precast, or steel and are placed at either the mid points or third points along the span and at the span ends. End diaphragms can provide restraint and act as a backwall. End diaphragms are located at the abutments and piers and can be full or partial depth. Intermediate diaphragms are usually partial depth.

**Figure 7.10.8** End and Intermediate Diaphragms on a Spread Box Beam Bridge

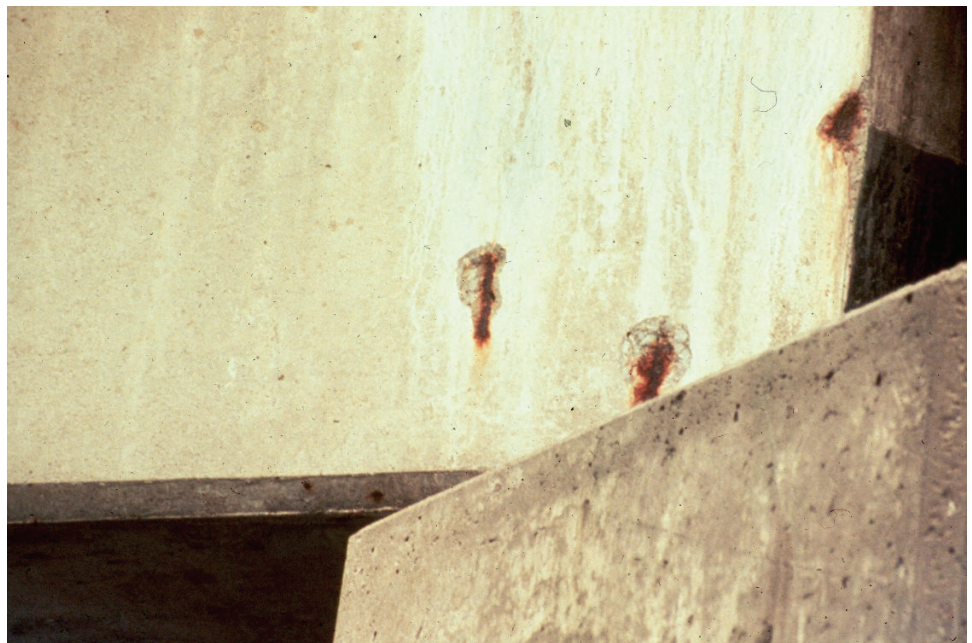
**Figure 7.10.12** Exposed Bars at End of Box Beam

Check for rust stains, which indicate corrosion of steel reinforcement (see Figure 7.10.12).

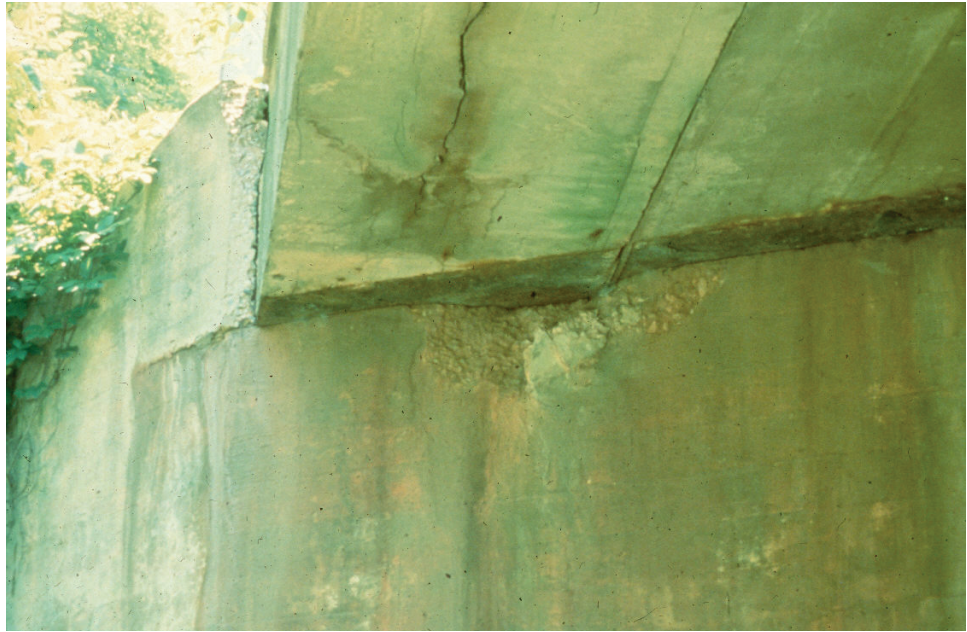
Check the bottom of beams for longitudinal cracks originating from the bearing location. These cracks are sometimes caused by the unbalanced transfer of prestress force to the concrete, or by the accumulation of water inside the box, freezing and thawing (see Figure 7.10.13).

**Figure 7.10.13** Longitudinal Cracks in Bottom Flange of Beam

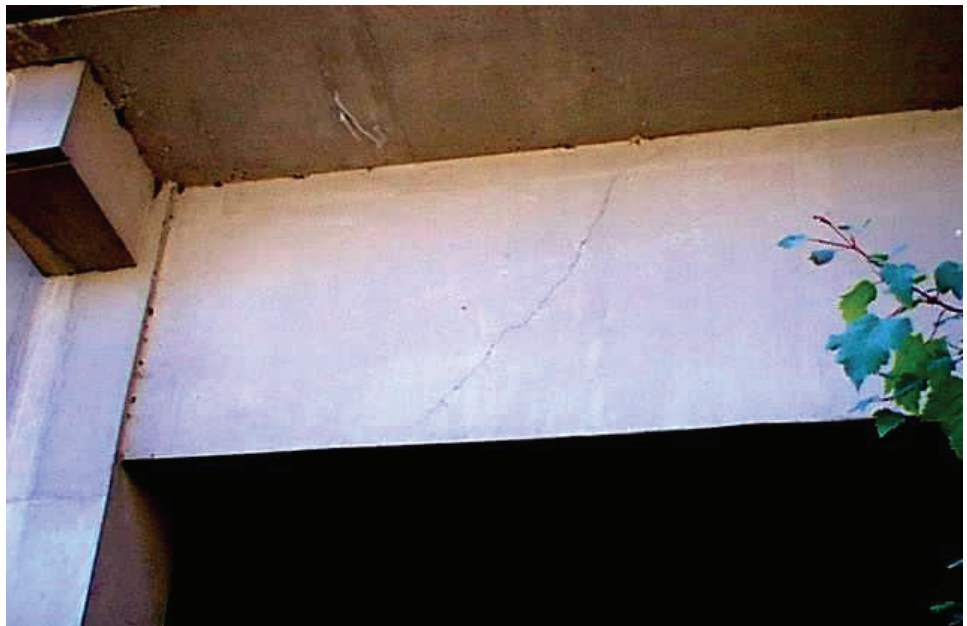
Check beam ends and sections over piers for diagonal shear cracks in webs. These web cracks will project diagonally upward at approximately a 45 degree angle from the support toward midspan (see Figure 7.10.14).

**Figure 7.10.14** Diagonal Shear Crack in Web of Beam

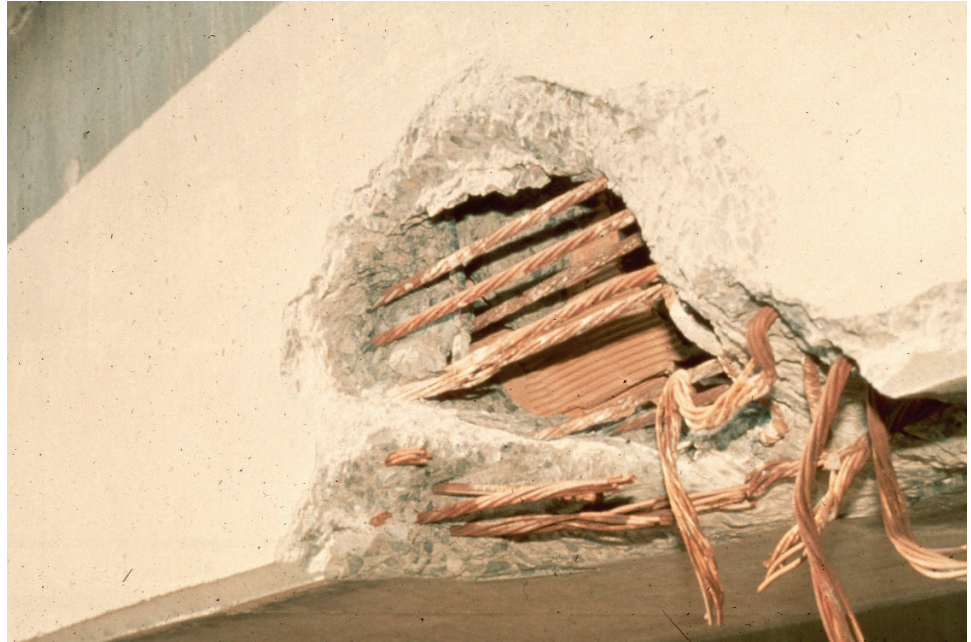
Check areas damaged by collision. A significant amount of prestressed concrete bridge deterioration and loss of section is due to traffic damage. Document the number of exposed and severed strands as well as the loss of concrete section. The loss of concrete due to such an accident is not always serious, unless the bond between the concrete and steel reinforcement is affected (see Figure 7.10.17).

**Figure 7.10.17** Close-up of Collision Damage

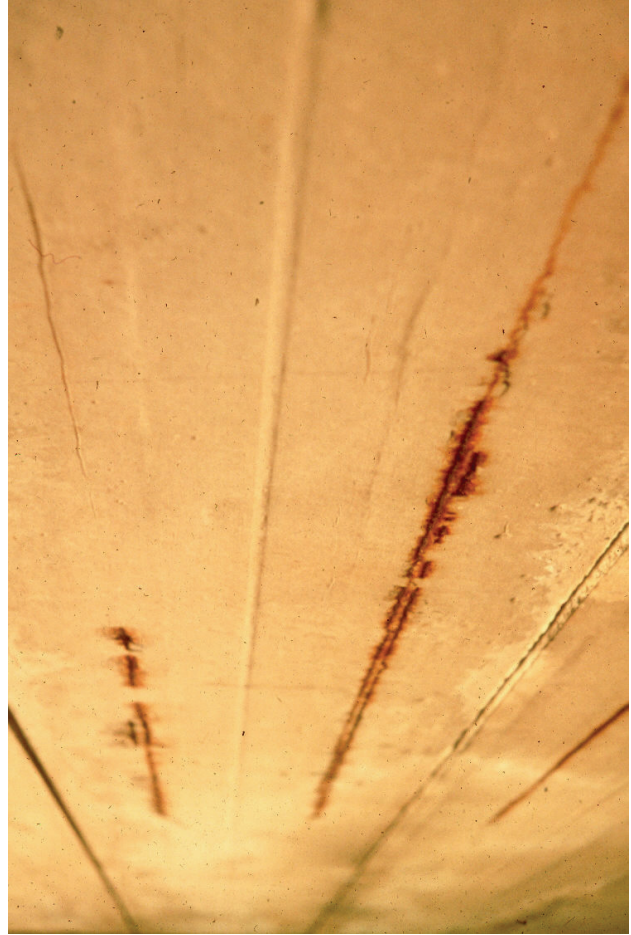
Note the presence of surface irregularities caused by burlap folds used in the old vacuum curing process. This dates the beam construction to the early 1950's and should alert the inspector to possible deficiencies common in early box beams, such as inadequate or non-existent drainage openings and strand cover (see Figure 7.10.18).

**Figure 7.10.18** Burlap Fold Depressions in an Early 1950's P/S Box Beam

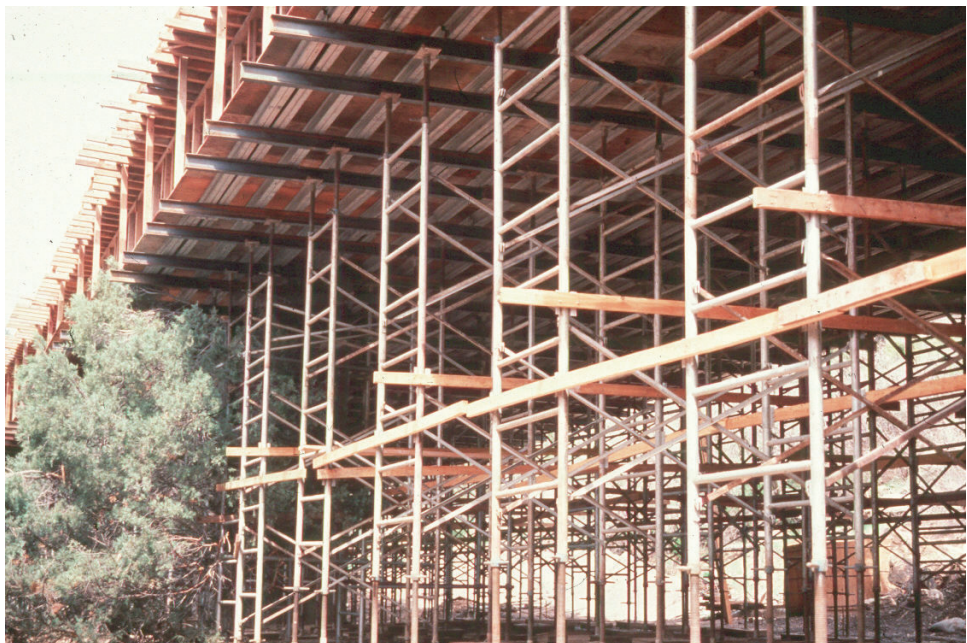
The high level casting method employs formwork supported by falsework. This technique is used when the structure must cross an existing feature, such as a roadway, railway, or waterway (see Figure 7.11.5).

**Figure 7.11.5** High Level Casting Formwork on Falsework

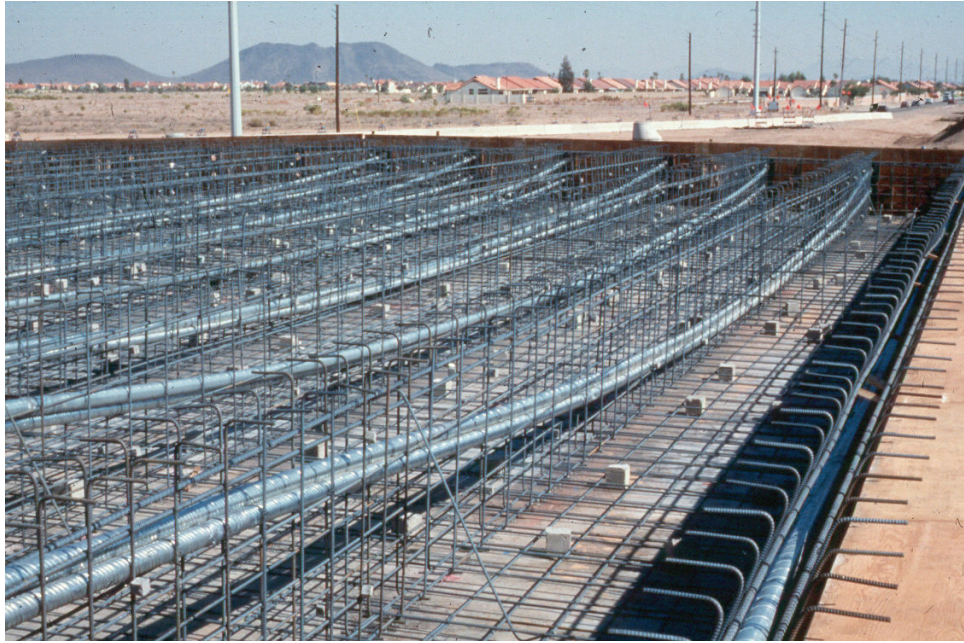
The at-grade casting method employs formwork supported by fill material or the existing ground. When the construction is complete, the fill beneath the bridge is removed. This technique is used when the structure is crossing, or is part of a new highway system or interchange (see Figures 7.11.6 and 7.11.7).

**Figure 7.11.6** At-grade Formwork with Post-tensioning Ducts

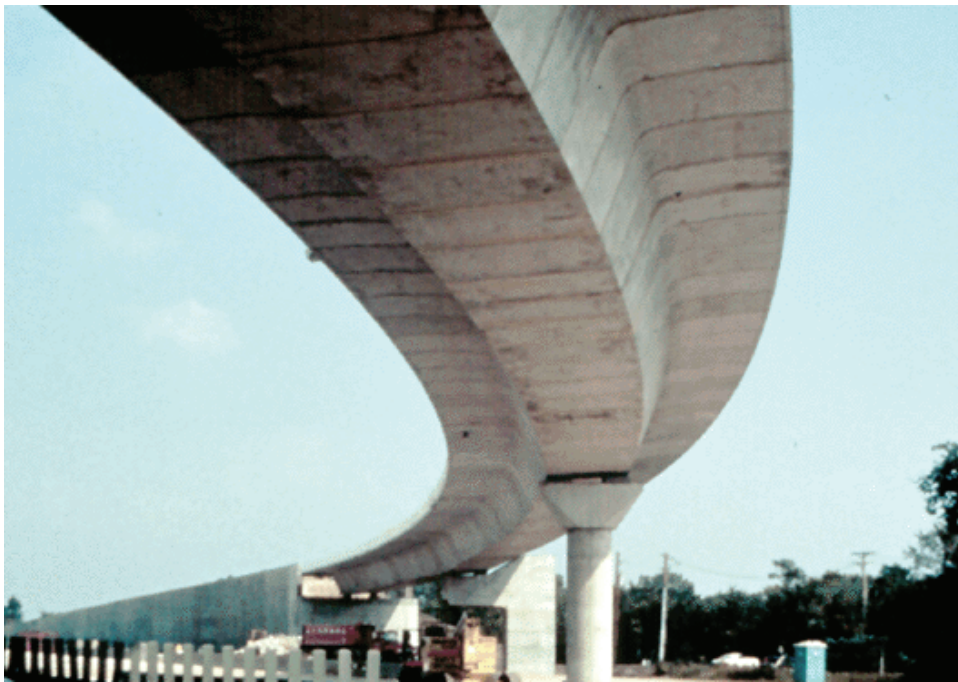
**Figure 7.11.13** Segmental Concrete Bridge

Many current box girders are built using segmental construction. A segmental concrete bridge is fabricated piece by piece. These pieces, or segments, are post-tensioned together during the construction of the bridge (see Figures 7.11.13 and 7.11.14). The superstructure can be constructed of precast concrete or cast-in-place concrete segments. Several characteristics are common to most segmental bridges:

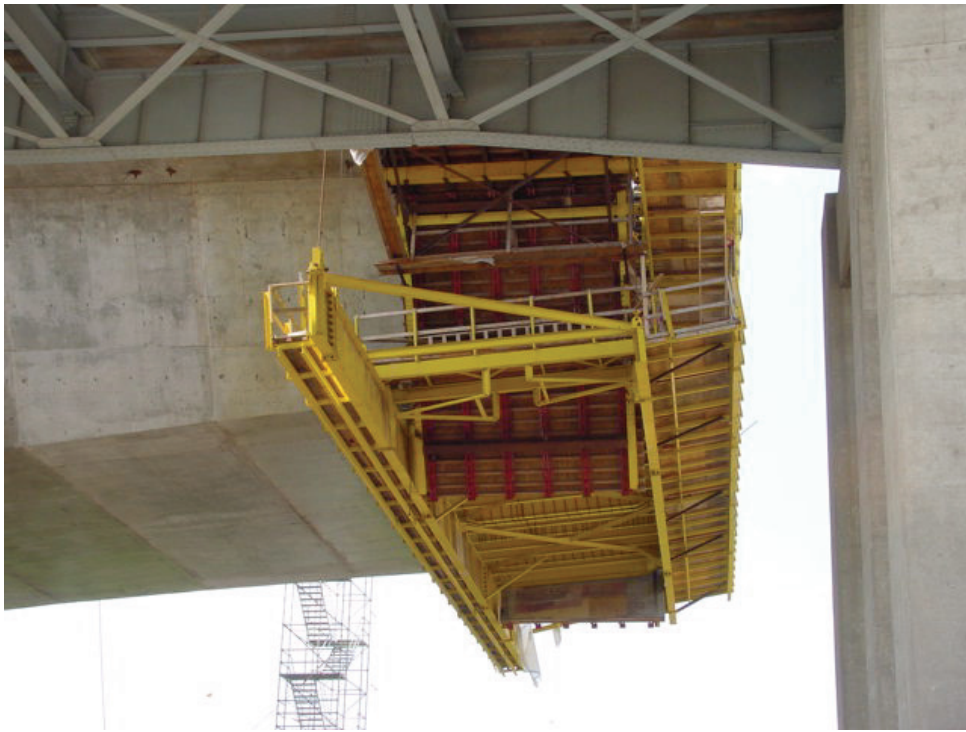
**Figure 7.11.15** Cast-in-place Box Girder Segment

Cast-in-place segmental construction is generally performed by supporting the segment formwork from the previous cast segment. Reinforcement and concrete is placed and the segment is cured. When the newly cast segment has reached sufficient strength, it is post-tensioned to the previous cast segments (see Figure 7.11.15). This process proceeds until the bridge is completed.

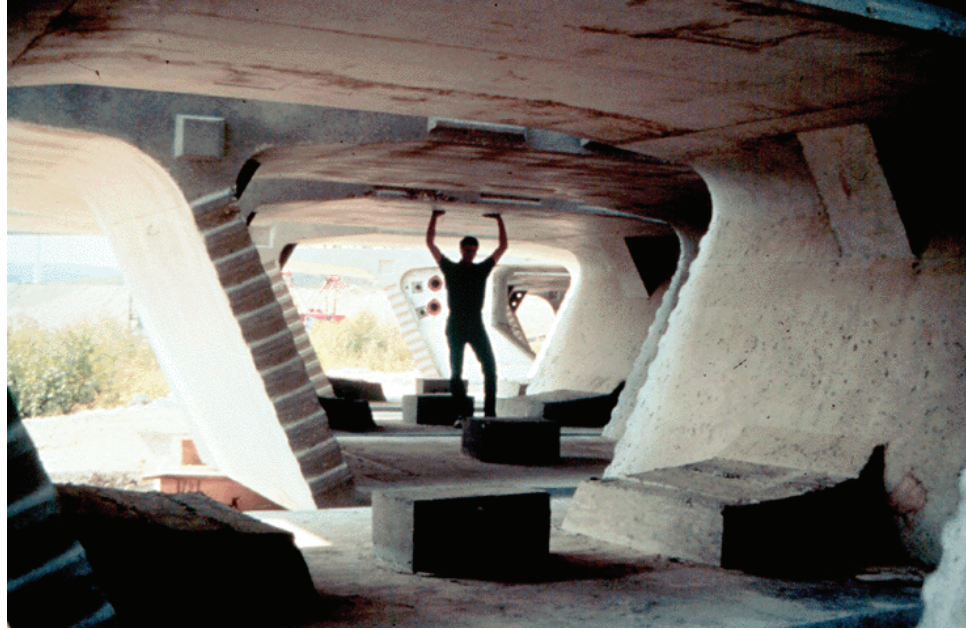
**Figure 7.11.16** Box Girder Segment

Precast segmental construction is performed by casting the individual segments prior to erecting them. The actual casting can take place near the project location or at an off-site fabrication plant. Once the precast segment is positioned adjacent to the previous placed segment, it is post-tensioned in the same manner as the cast-in-place segment previously mentioned. This process also repeats itself until the bridge is completed (see Figure 7.11.16).

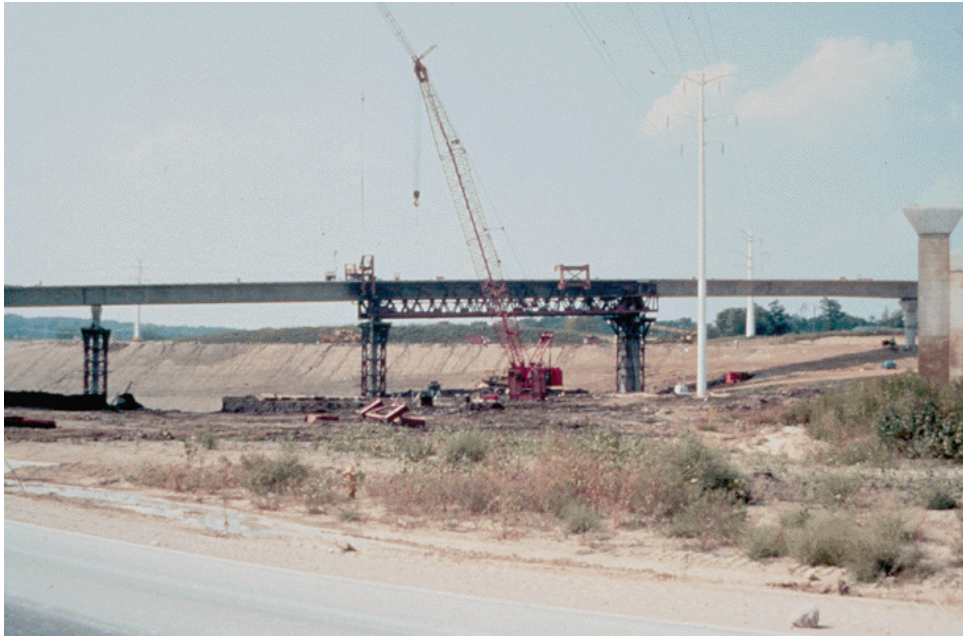
**Figure 7.11.20** Span-by-Span Construction (with Erection Truss)

This form of construction may require a temporary steel erection truss or falsework, which spans from one pier to another. The erection truss provides temporary support of the individual segments until they are positioned and post-tensioned into their final configuration. This type of construction allows a total span to be erected at one time. Once the span has been completed the erection truss is removed and repositioned on the next adjacent span. This procedure is repeated until all the spans have been erected (see Figures 7.11.20 and 7.11.21).

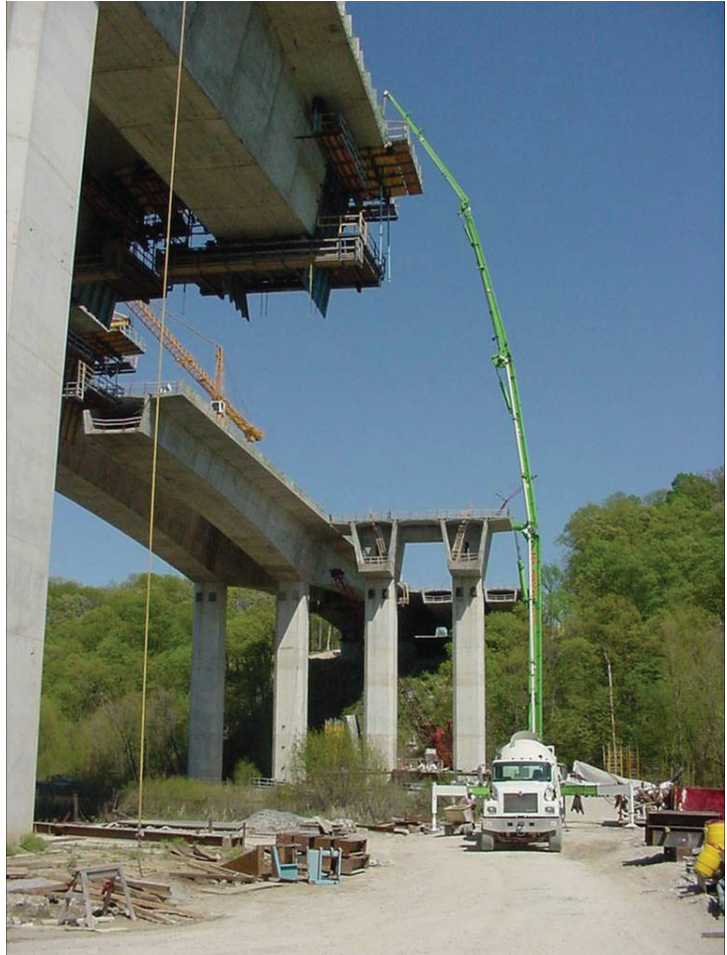
**Figure 7.11.23** Progressive Placement Construction

This form of construction is much like the span-by-span construction described above. Construction proceeds outward from a pier towards an adjacent pier and once completed, the process is repeated in the next span and so on until the bridge is completed (see Figure 7.11.23). Because of the large bending forces associated with this type of construction, temporary bents or erection cables tied off to a temporary erection tower are often employed.

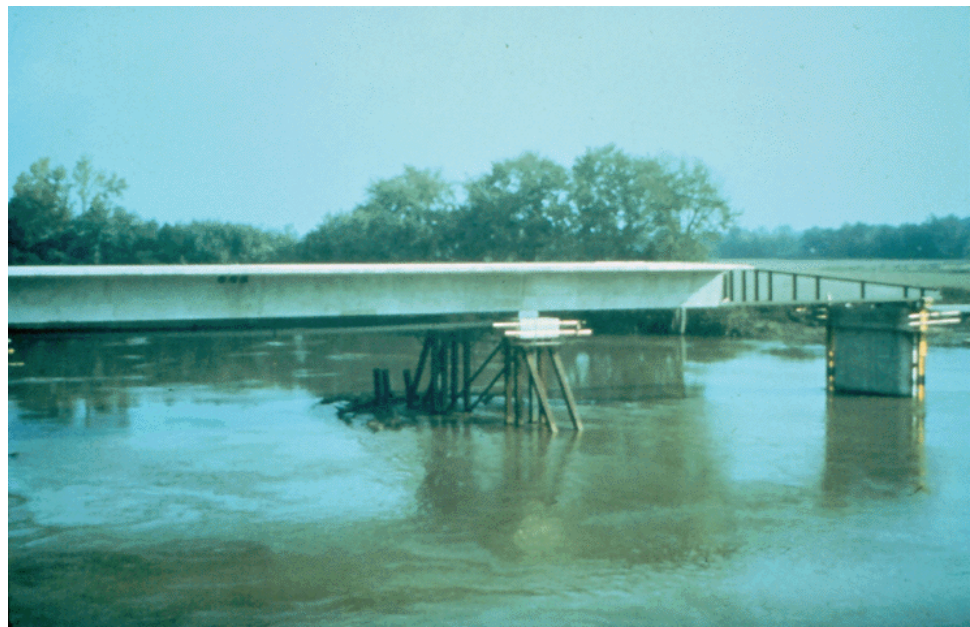
**Figure 7.11.25** Incremental Launching Overview (Note Temporary Pile Bent)

To aid the advancement and guide the already completed segments, a steel launching nose is attached to the leading segment. If the spans become very large, temporary bents are often used to reduce the large negative bending effects developed in the completed cantilever segments (see Figure 7.11.25).

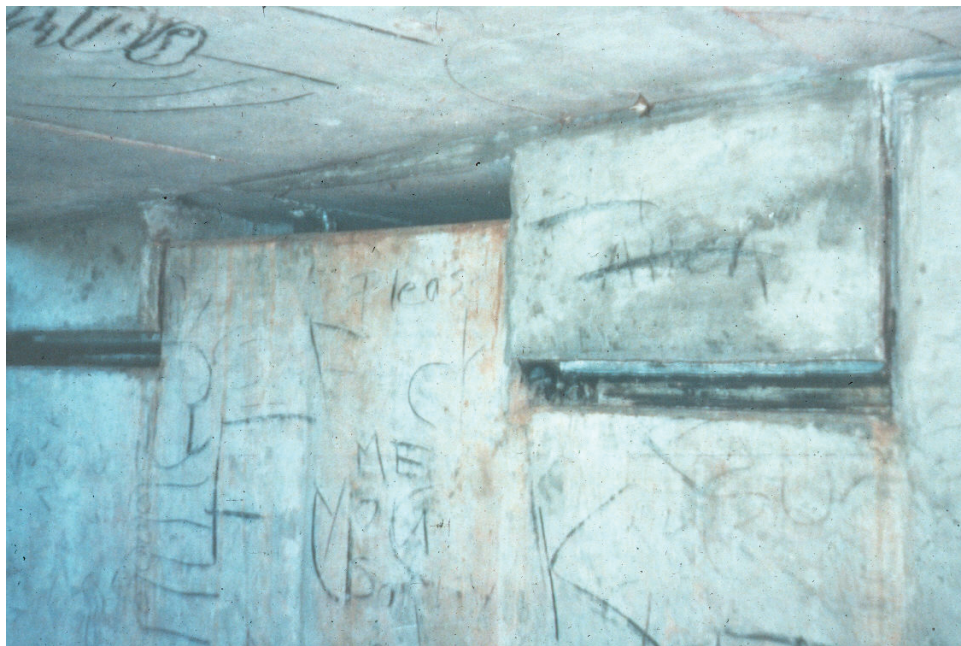
**Figure 7.11.26** Bearing Area of a Cast-in-place Box Girder Bridge

The effects of temperature, creep, and concrete shrinkage may produce undesirable conditions at the bearings. Check the bearing areas and the bearings for proper movement and movement capability (see Figure 7.11.26).

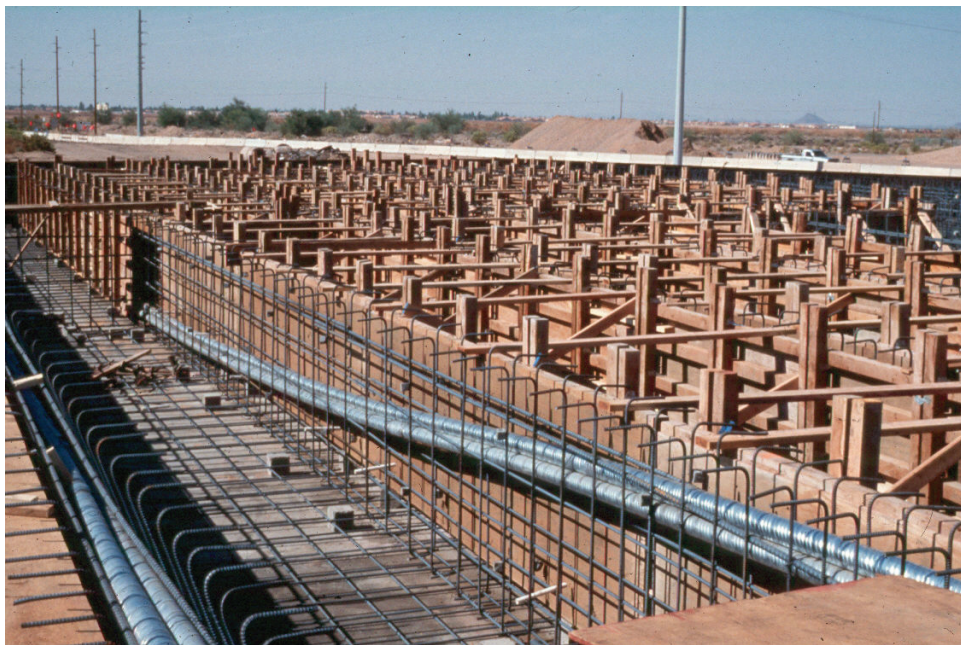
**Figure 7.11.36** Post-tensioning Tendon Duct

Post-tensioning - Cracking can occur along any of the lines of post-tensioning tendons. For this reason it is important for the inspector to be aware of where tendons are located in the box section (see Figure 7.11.36). This cracking may be the result of a bent tendon, a misaligned tendon with insufficient concrete cover or voids around the tendons. Shrinkage of concrete adjacent to large tendons has also caused this type of cracking.

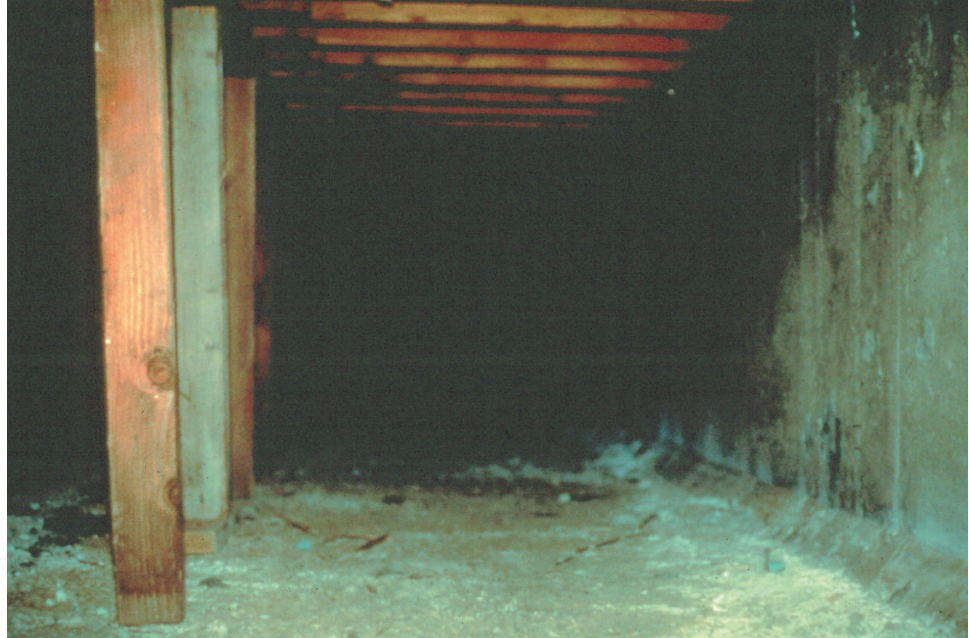
**Figure 7.11.37** Interior Formwork Left in Place

**Overstress** - Older cast-in-place box girder interiors should be inspected to verify that inside forms left in place do not provide unintentional load paths, which may result in overloading elements of the box (see Figure 7.11.37).

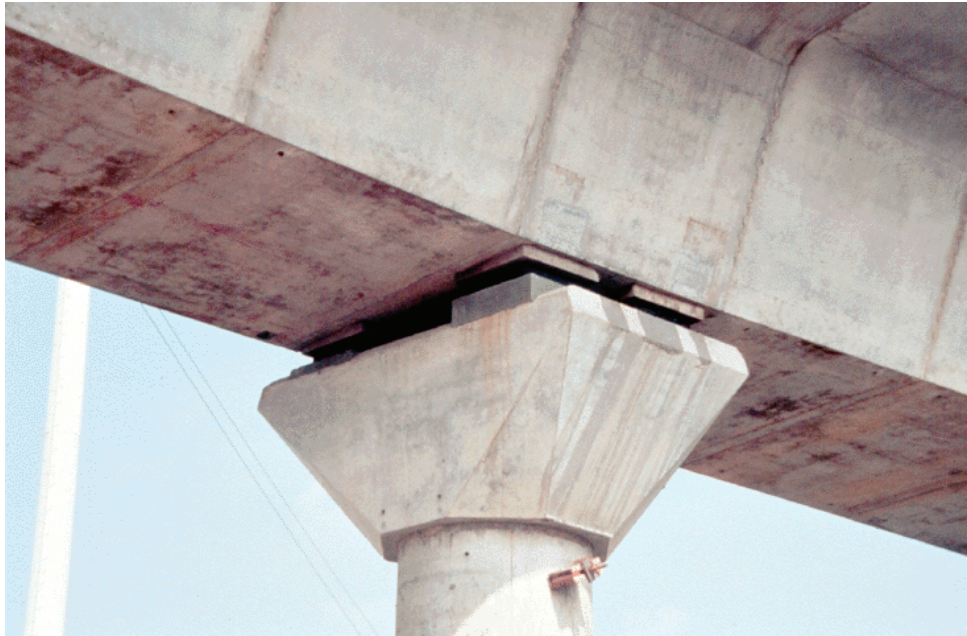
**Figure 7.11.39** Segmental Box Girder Bearings at Intermediate Pier

Due to the inherent behavior of prestressed concrete structures, the effects of temperature, creep and shrinkage of the concrete may produce undesirable conditions to the bearings. These undesirable conditions take the form of distorted elastomeric bearings or loss of movement to mechanical bearings. Additionally, the areas where bearings interface with the bottom flange of the box girder need special attention. Large vertical forces from the superstructure are required to be transmitted to the bearings and, therefore, sizable bearing stresses are produced in these areas (see Figure 7.11.39).

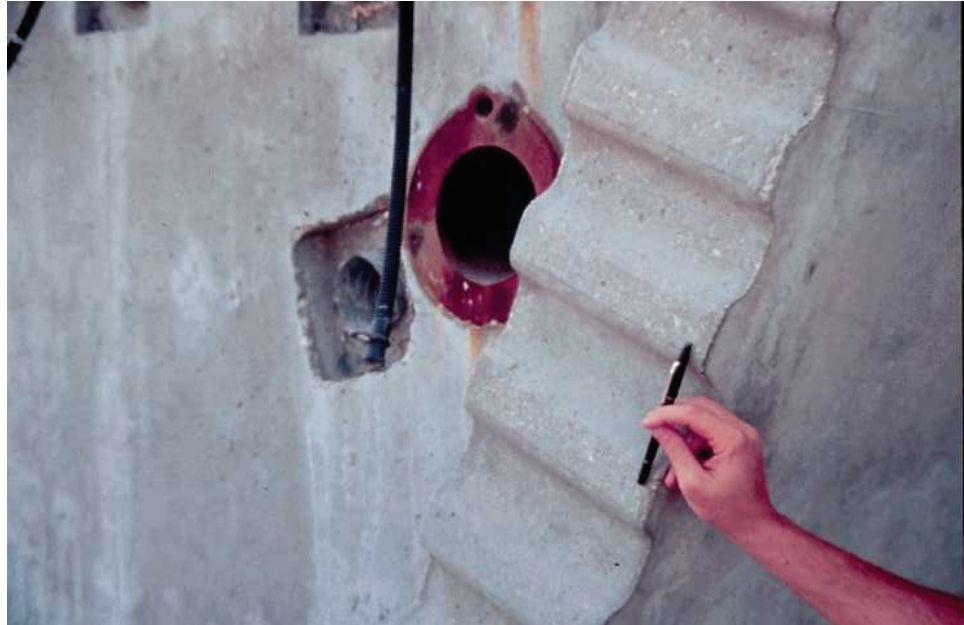
**Figure 7.11.41** Close-up View of Box Girder Shear Keys

Joints should be inspected for crushing and movement of the shear keys (see Figure 7.11.41). The presence of open or loose joints needs to be documented. Areas where the type of construction required closure joints or segments to be poured in place will
